<b>Project Name:</b> Gold King Mine	<b>Site Location:</b> Silverton, San Juan County, Colorado	<b>Project No.</b> 0001/1408-01
--	---	------------------------------------

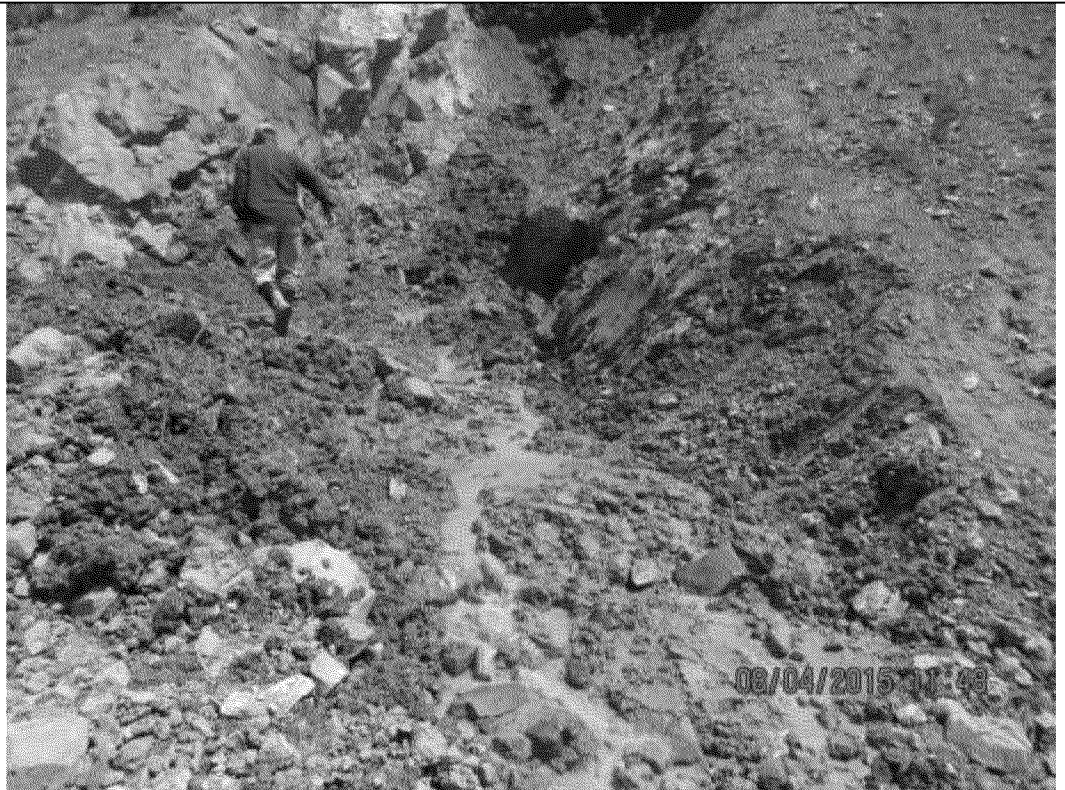
**Photo No.**  
**5**

DRMS looking at adit excavation progress.

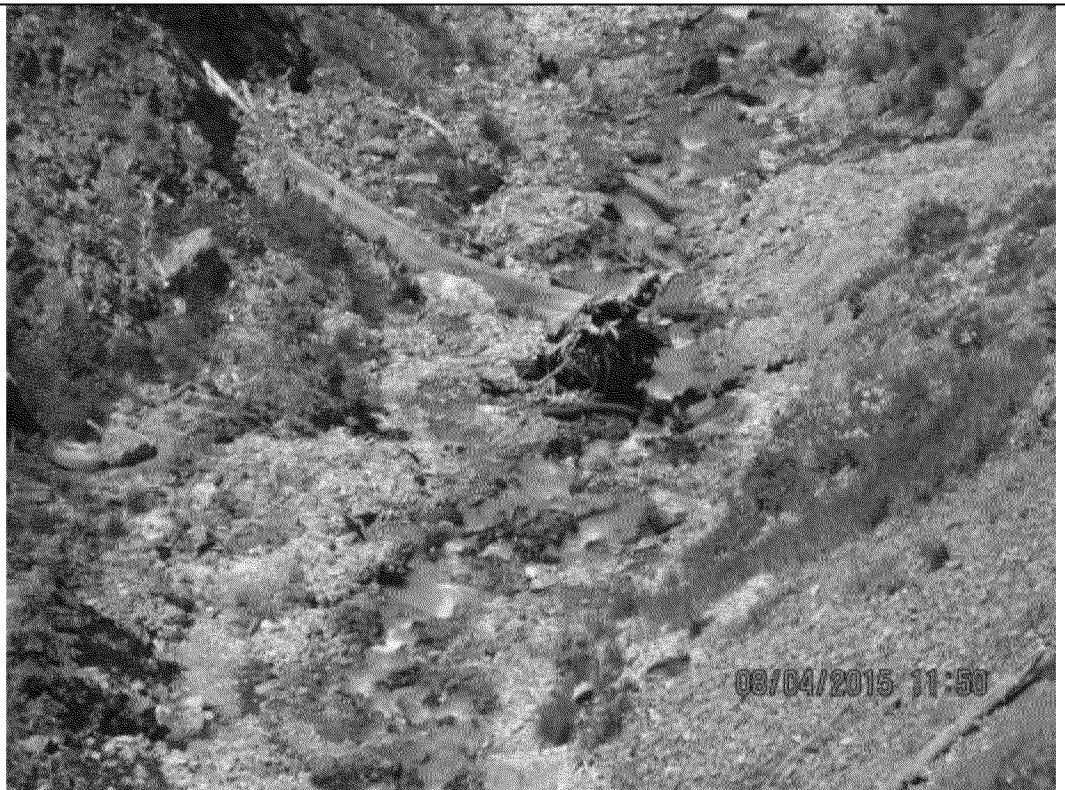
**Photo No.**  
**6**

Water minimally murky from disturbed soil and water entering the North Fork from site.

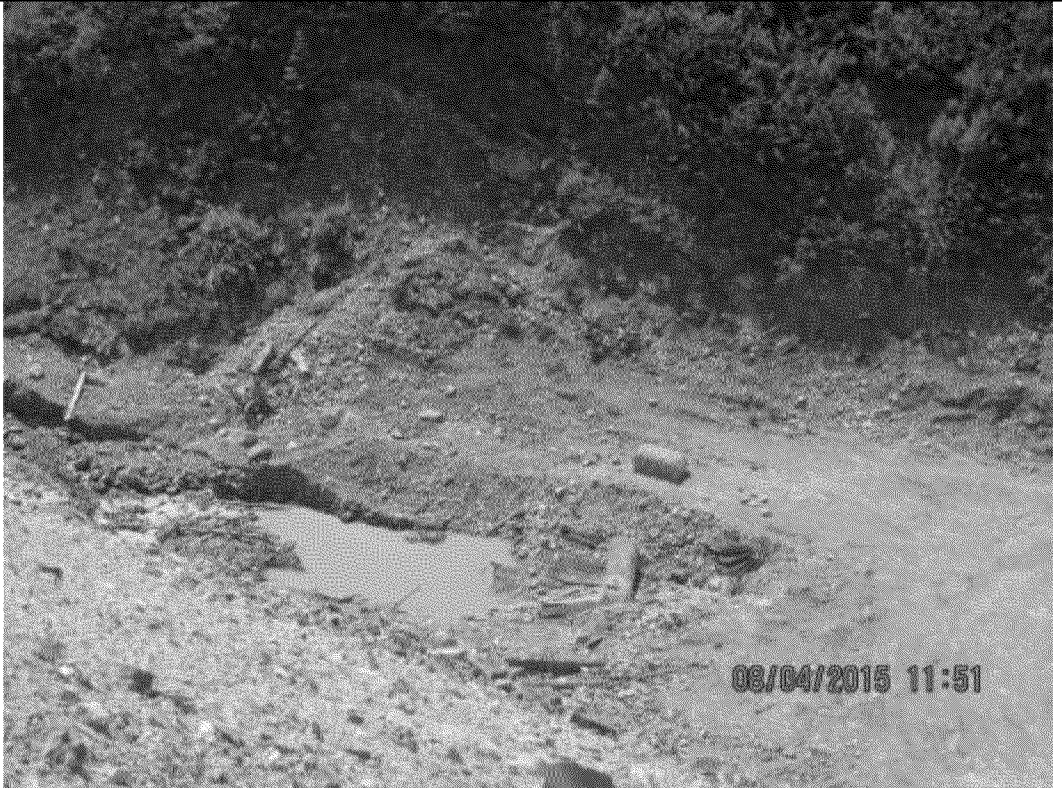
<b>Photo No.</b> 7	<b>Date:</b> 08/04/2015

<b>Direction Photo Taken:</b>  South/Down		
<b>Description:</b> Hay bales installed as filter for sediment in North Fork.		
<b>Photo No.</b> 8	<b>Date:</b> 08/04/2015

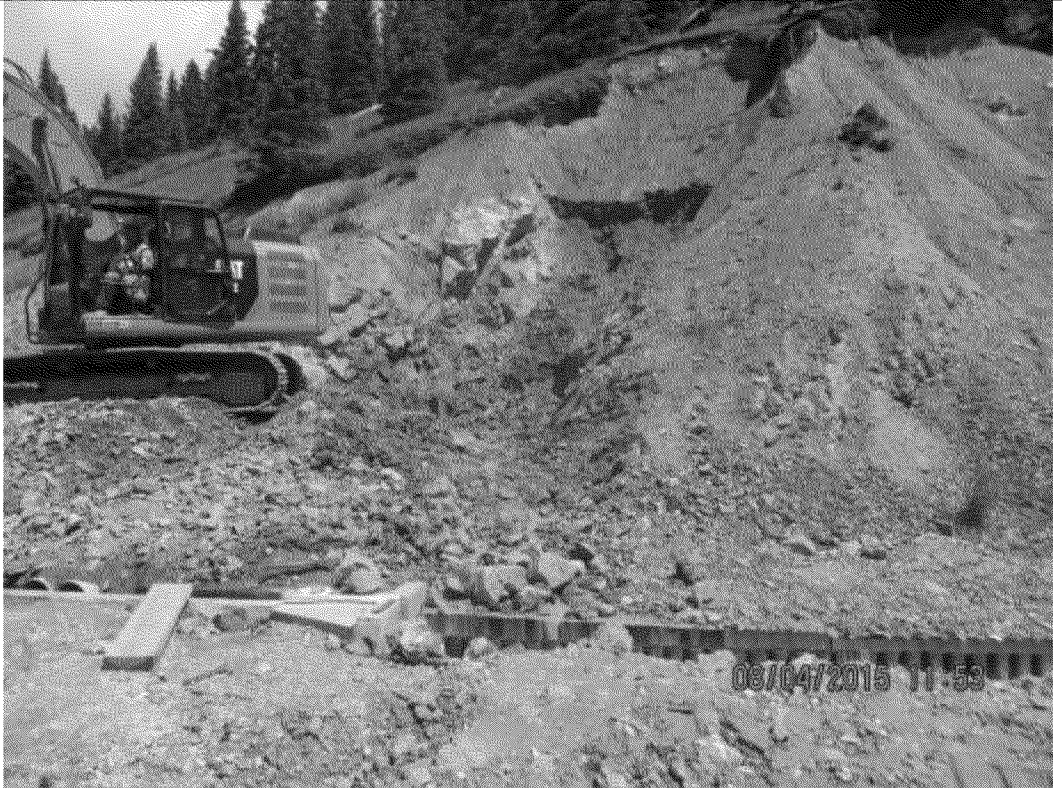
<b>Direction Photo Taken:</b>  Northwest		
<b>Description:</b> Continuing excavation at the collapsed adit, no solid bedrock found for tunnel support.

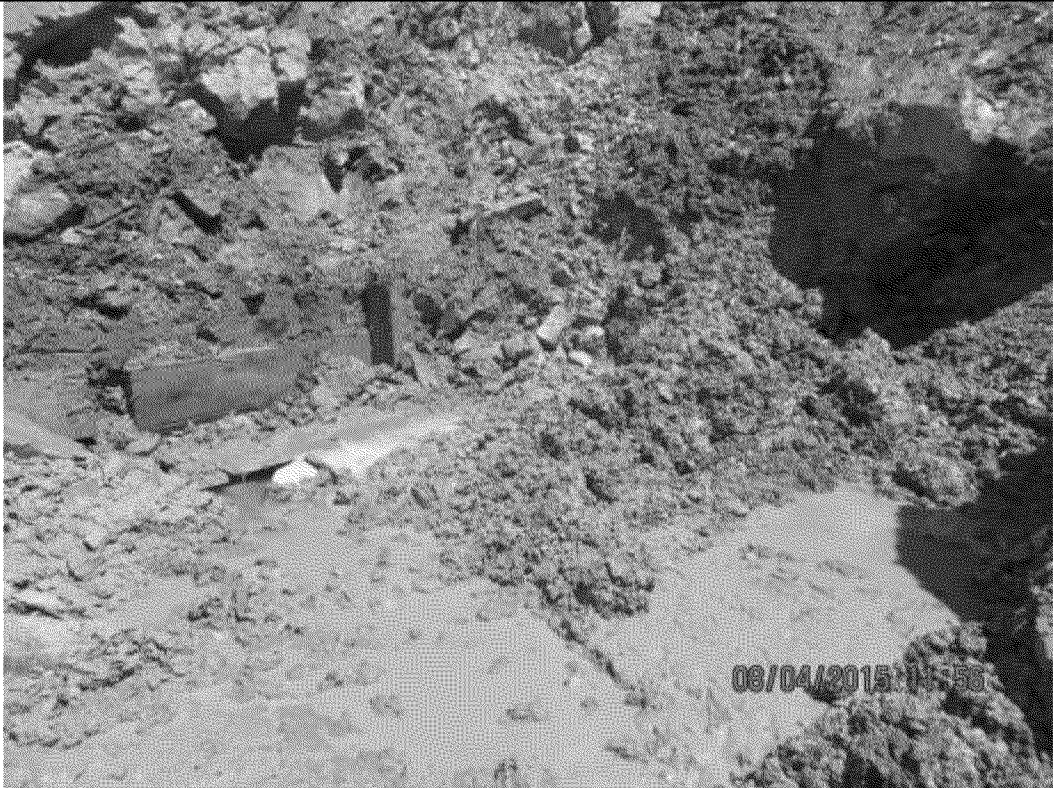
<p><b>Photo No.</b> <b>9</b></p>	<p><b>Date:</b> 08/04/2015</p>

<p><b>Direction Photo Taken:</b></p> <p>Northeast</p>		
<p><b>Description:</b> First signs of adit, support pillar with lagging.</p>		
<p><b>Photo No.</b> <b>10</b></p>	<p><b>Date:</b> 08/04/2015</p>

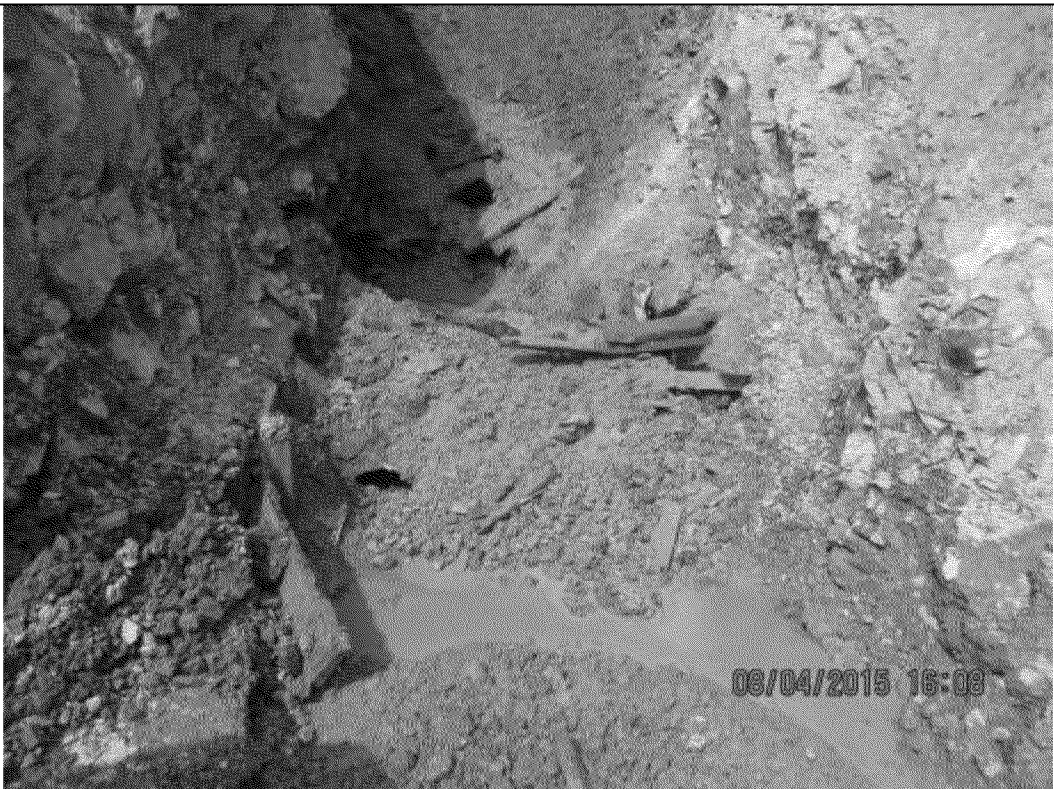
<p><b>Direction Photo Taken:</b></p> <p>North</p>		
<p><b>Description:</b></p> <p>Collapsed supports uncovered above anticipated adit, no sign of bedrock above the adit area.</p>

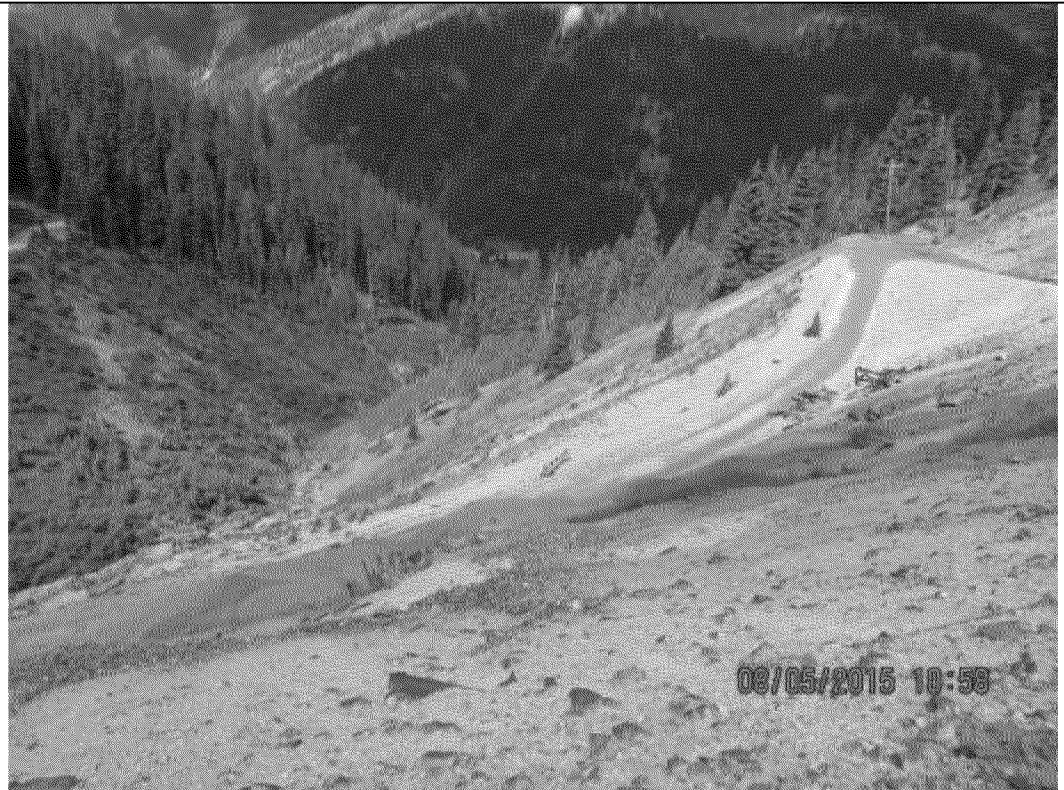
**Photo No.**  
**21**

Water flowing along access road and across waste dump.

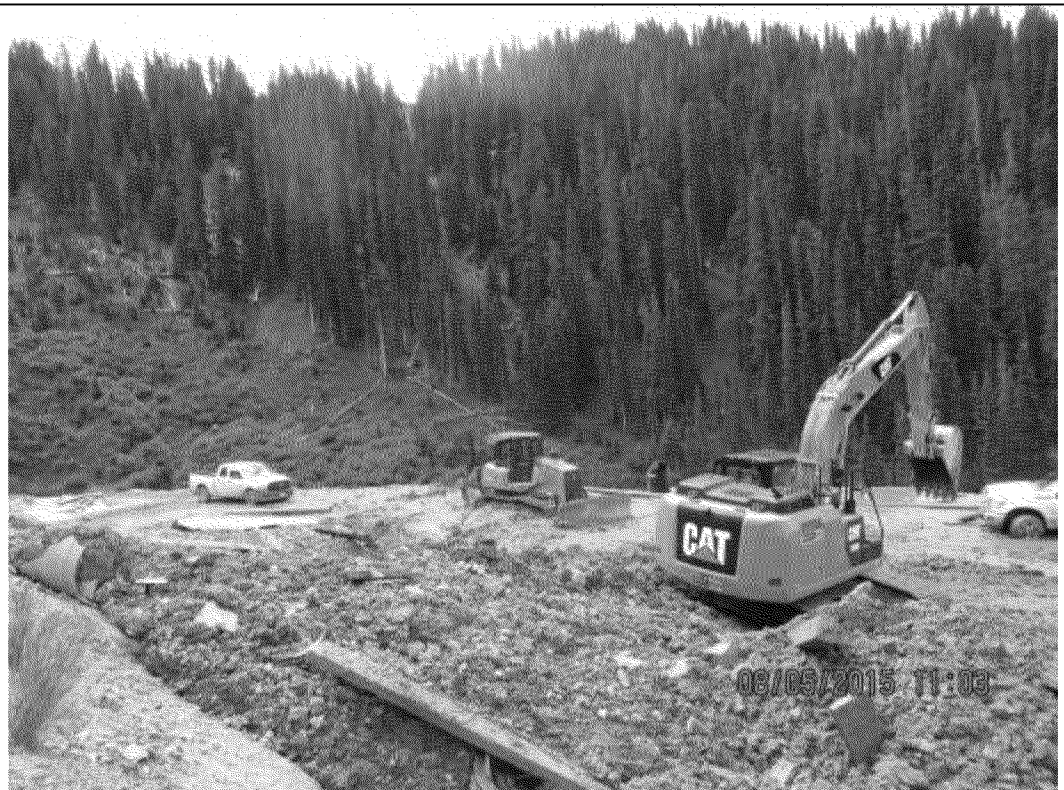
**Photo No.**  
**22**

Water flowing over the edge of the waste dump and collapsing the edge.

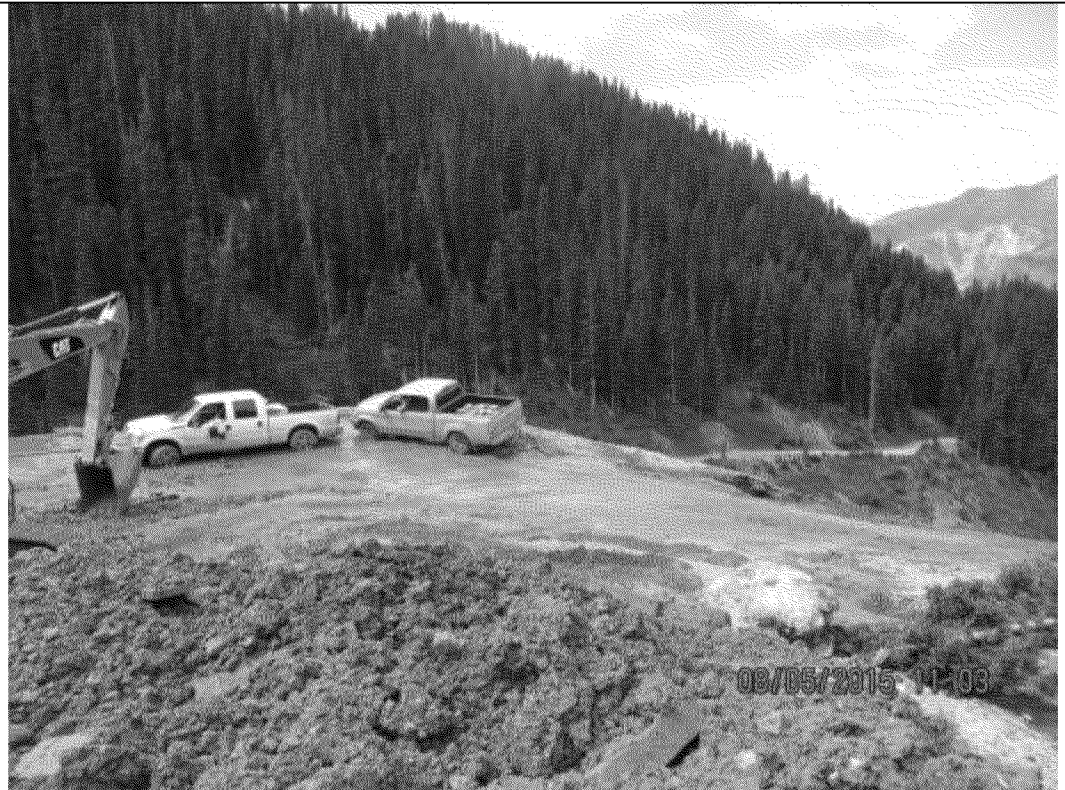
**Photo No.**  
**23**

Exit route starting to collapse

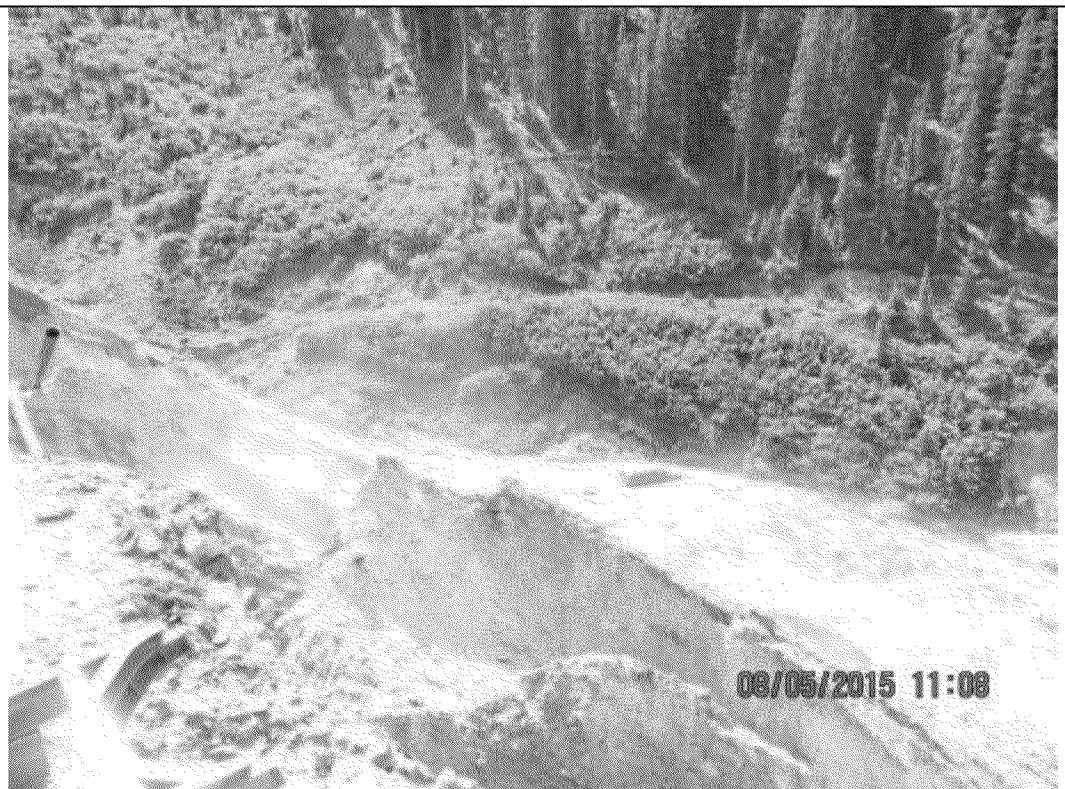
**Photo No.**  
**24**

Edge of the tailings dump collapsed, suburban trapped and half submerged in center of photo.

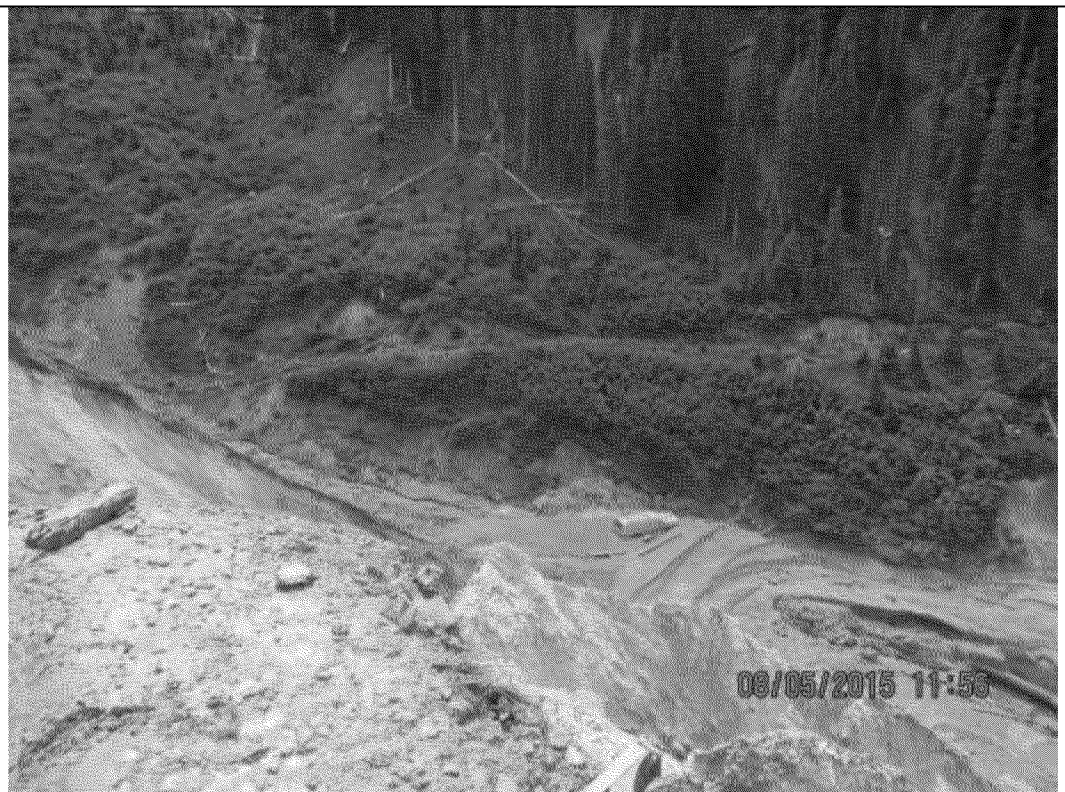
**Photo  
No.  
30**

Collapsed portion of  
waste dump and road  
wash out.

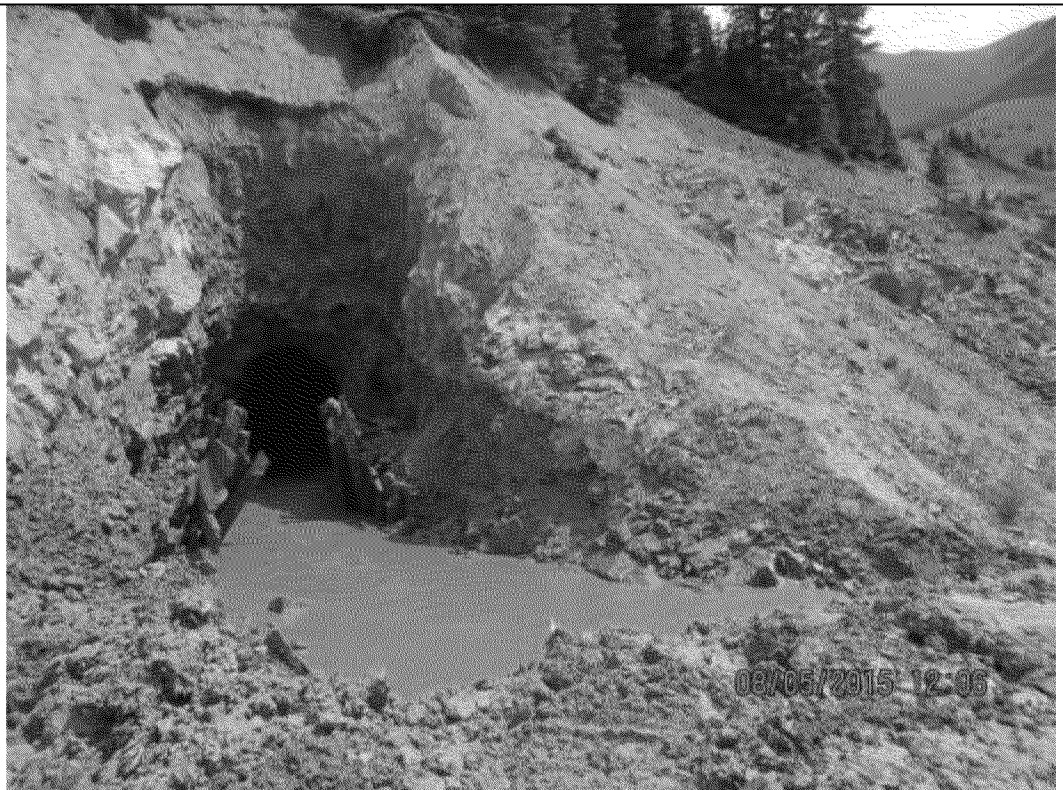
**Photo No.**  
**32**

Exposed adit and redirected flow, flow is beginning to subside.

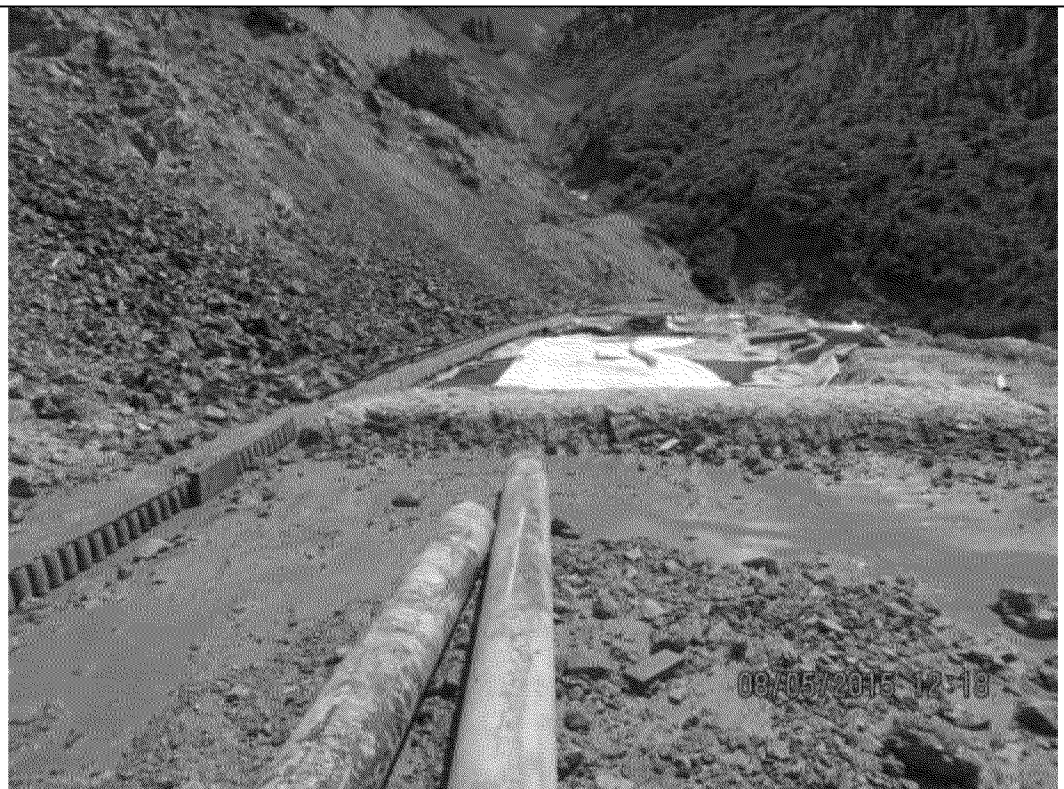
**Photo No.**  
**36**

Existing flow channel at maximum capacity.

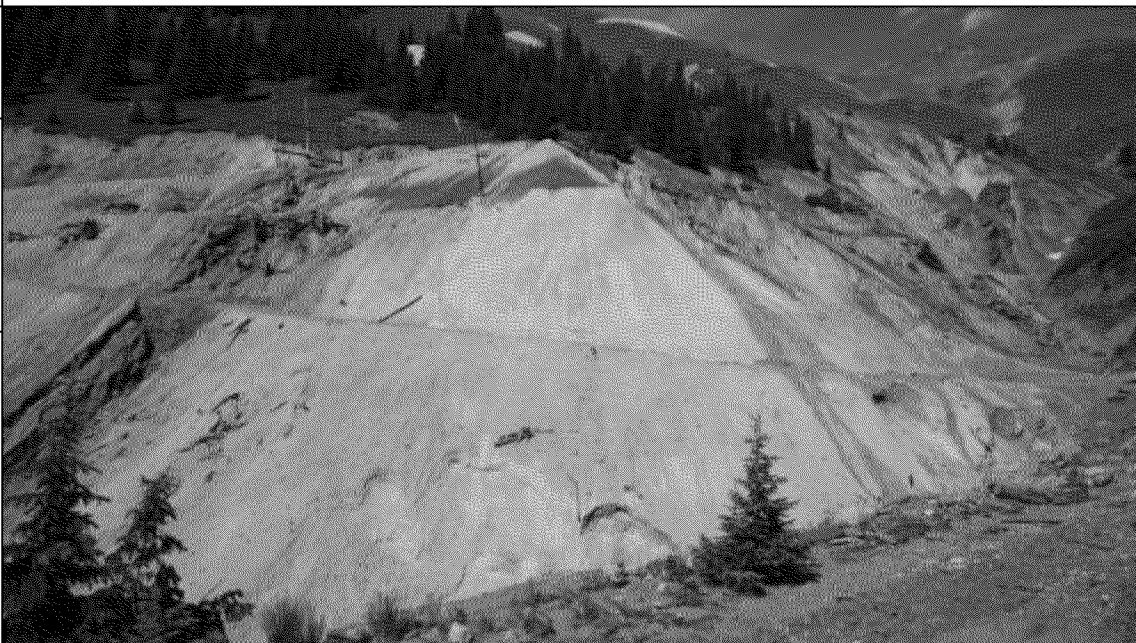
<b>Direction Photo Taken:</b>  Northeast		
<b>Description:</b> Gold King Mine tailings dump after water discharge.
